TECHNICAL NOTE

D-263

EFFECTS OF MELTING PRACTICE AND ALUMINUM COATING ON THE LIFE OF

GMR 235 BUCKETS OPERATED AT 1650° F IN A TURBOJET ENGINE

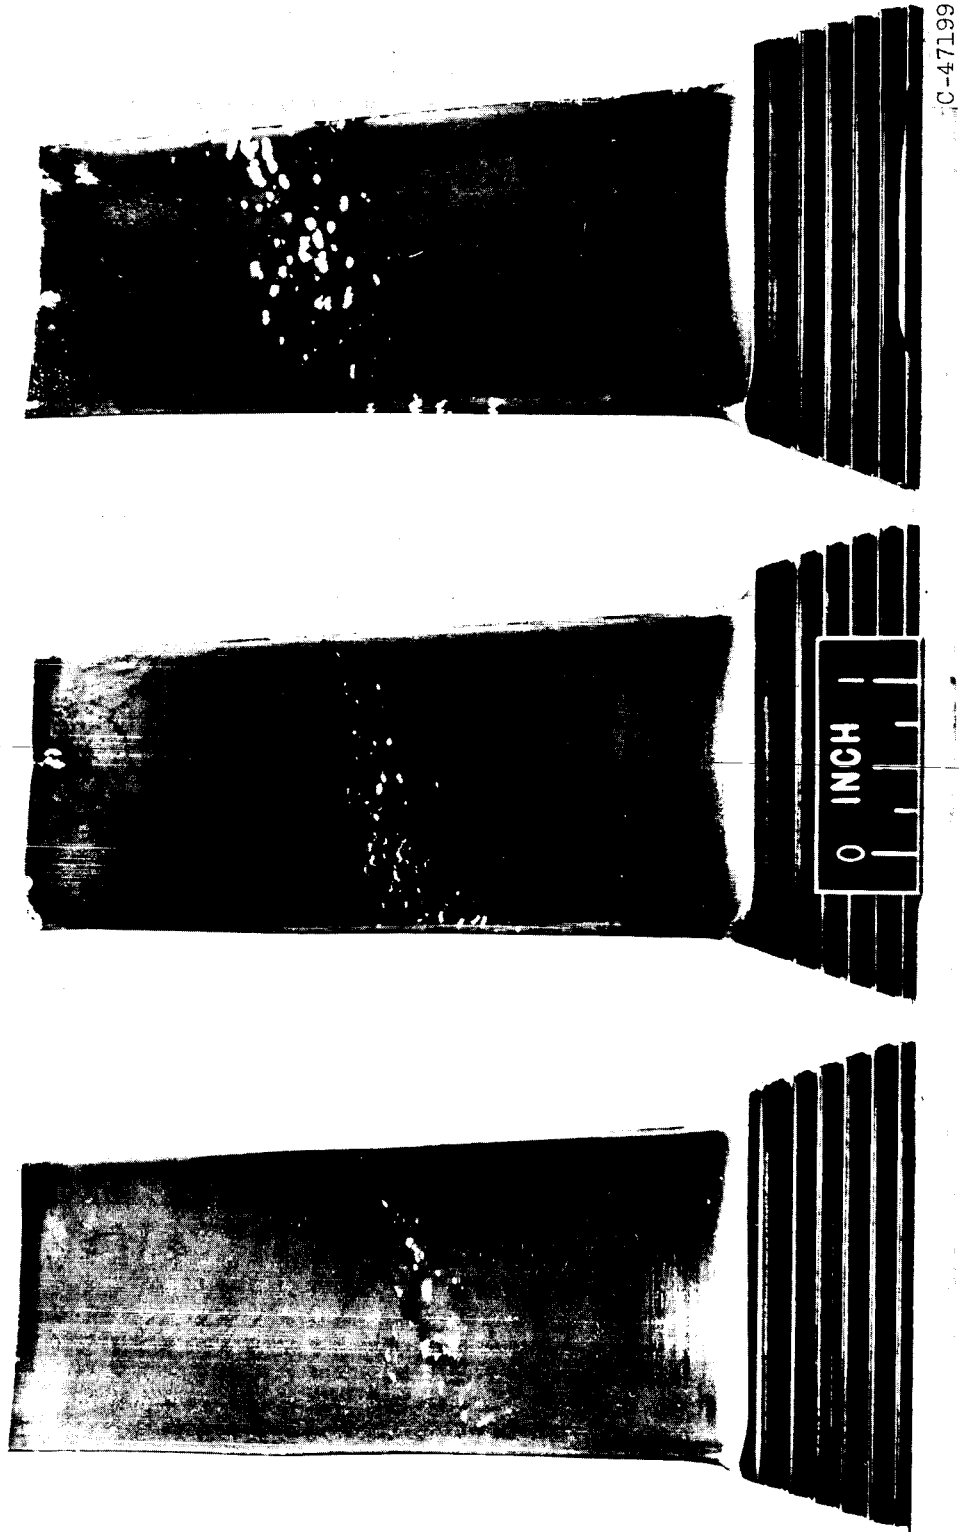
Figure 5. - Stress-rupture cracking occurring in airfoil of air-melted GMR 235 buckets.

Fracture mechanism. - Figures 5 to 8 show typical failures of GMR 235 buckets encountered during testing. Figure 5 shows typical stress-rupture cracking that ultimately would lead to fracture. The cracks occurred in various locations along the span from 1.5 to 3.2 inches above the base platform. These cracks were intergranular in nature, and the majority of them occurred in the critical zone (fig. 4), where stress-rupture would be expected. Figure 6 shows a failure that was initiated by stress-rupture and was fractured by a combination of stress-rupture and mechanical fatigue. Figure 7 shows the progression of a typical mechanical-fatigue failure until the cross-sectional area was too small to support the imposed load and the final separation occurred as a tensile failure. Figure 8 shows a slightly damaged bucket, which indicates that GMR 235 can react in either a brittle or a ductile manner when impacted by flying fragments of fractured buckets. The majority of the damage-failed buckets showed a brittle type of fracture, however. All of the vacuum-melted buckets failed as a result of damage or fatigue, whereas the majority of the air-melted buckets failed by stress-rupture cracking.

- (a) Aluminized, group 8; considered failed at 114.5 hours of rated-speed operation.
- (b) As-cast, group 5; considered failed at 99 hours of rated-speed operation.
- (c) Aged, group 7; considered failed at 33.5 hours of rated-speed operation.

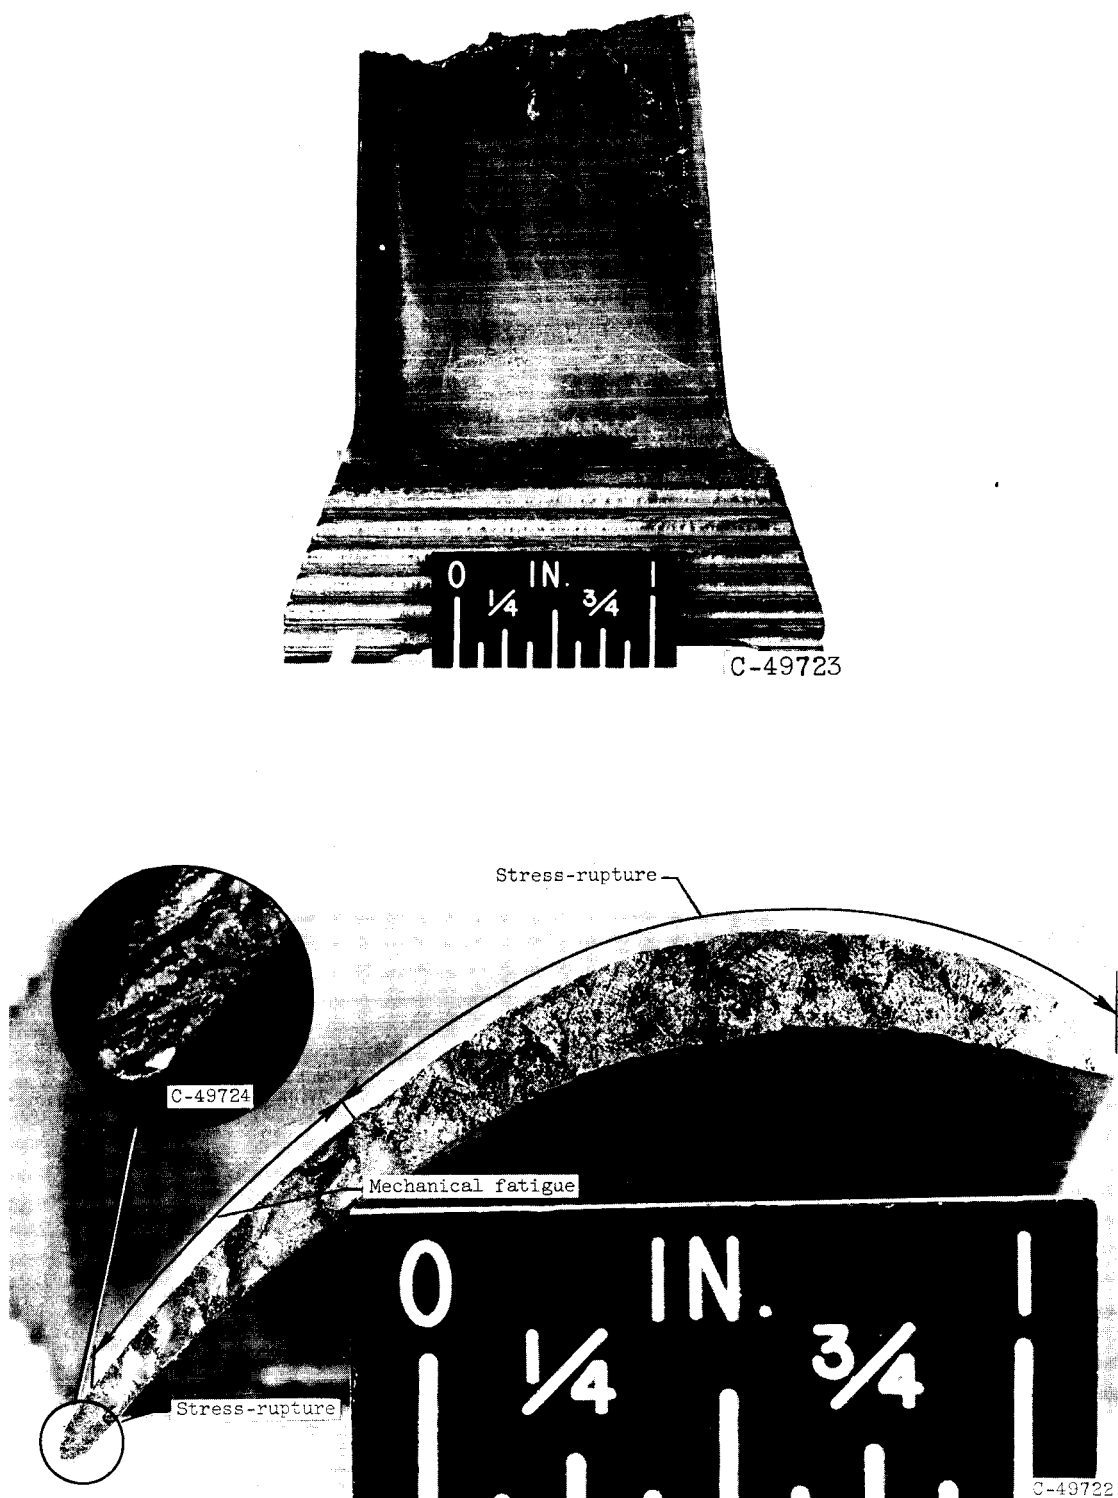
Figure 6. - Typical stress-rupture and mechanical-fatigue fracture. Air-melted diffusion-heat-treated group-6 bucket operated for 74.5 hours.

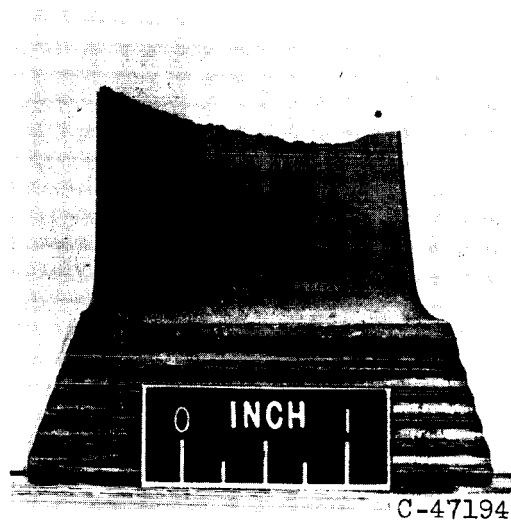
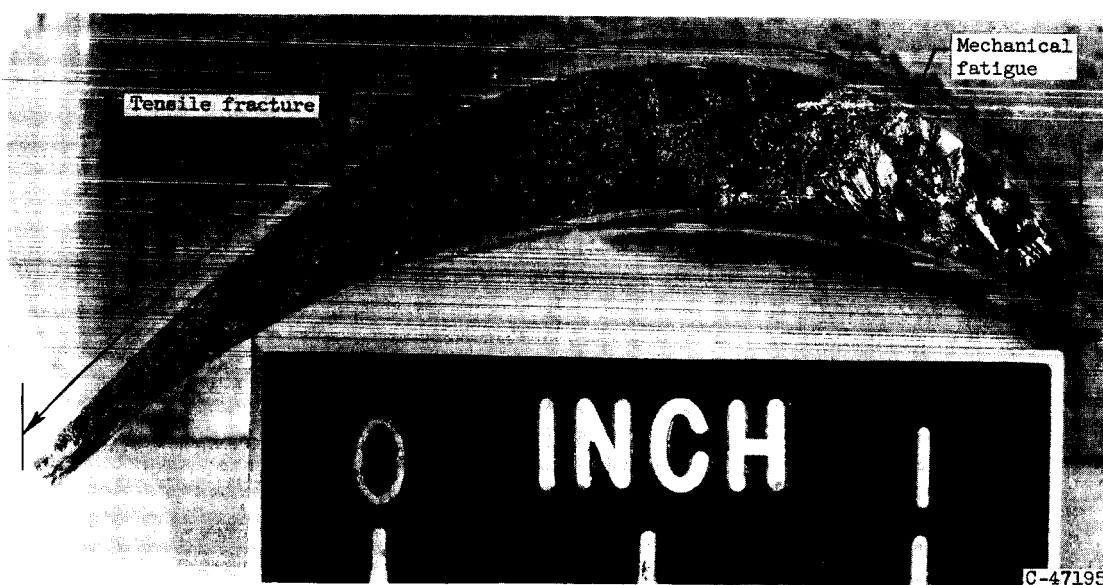
Figure 7. - Typical mechanical-fatigue fracture. Vacuum-melted aluminized group-2 bucket operated for 268.6 hours.

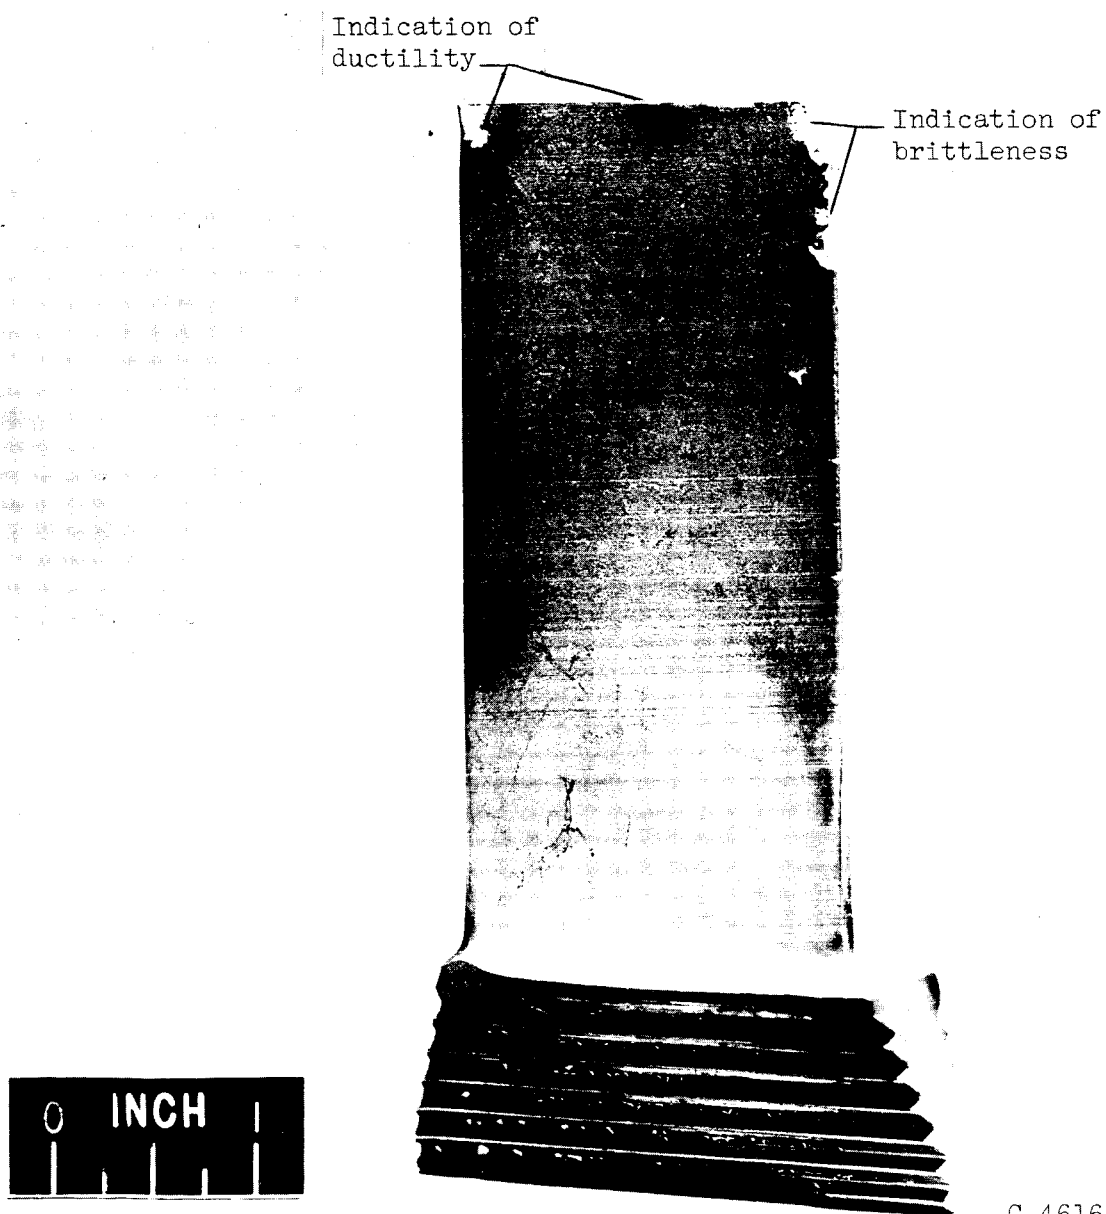
(4) Damage: Buckets showing nicks or dents so extensive that fracture would probably occur in a short time were removed from the engine and were considered to be damage failures. Also, buckets in which fracture was seen to have propagated from a nick or dent were considered damage failures. Damage failures were not considered in the analysis of the data.

Figure 8. - Damaged bucket indicating both brittleness and ductility to impaction by flying fragments.

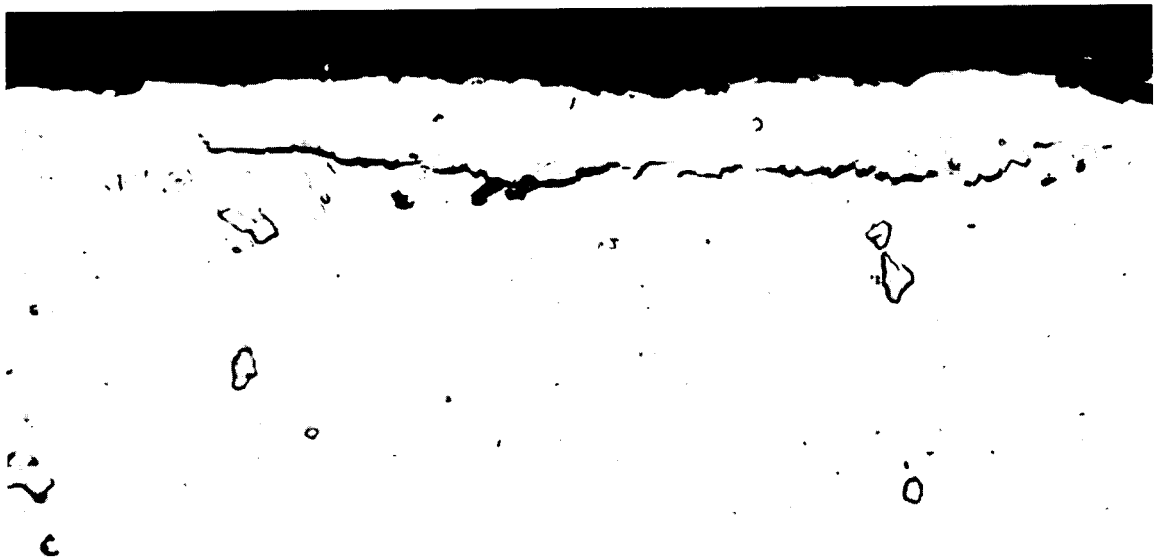
The thickness of the coating varied slightly and ranged from approximately 0.6 mil on the edges to approximately 0.4 mil on the body of the airfoil. Cracks were noted along the coating - base-metal interface, as shown in figure 16. The cracks were small and occurred at random locations in the buckets and, in some instances, extended from the interface to the outside of the coating (not shown in fig.). Their presence could not be detected by PE zygo inspection, so it is possible that they occurred during specimen preparation.

Figure 16. - Section of aluminized bucket showing crack in coating - base-metal interface. Unetched; X750.

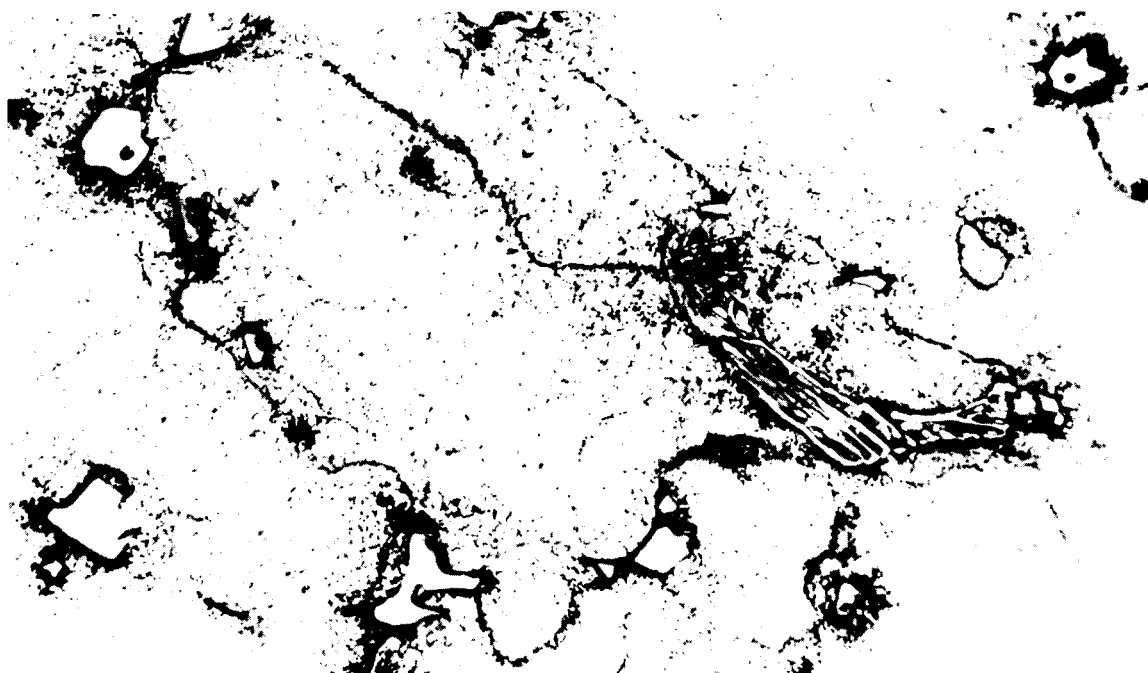
An indication that the microstructure of the vacuum-cast materials was more stable than the structure of the air-melted buckets was revealed in two ways: First, the as-cast air-melted operated buckets seemed to show an agglomeration of precipitates (fig. 17(c)); this agglomeration occurred after 121 hours of operation. On the other hand, the as-cast vacuum-melted operated buckets showed no appreciable agglomeration of precipitate after 213 hours (fig. 17(a)). An additional point that might be made is that the aluminized vacuum-melted buckets (fig. 17(b)) did not age to as great a degree (microstructurally) as did the aluminized air-melted buckets (fig. 17(d)); the structure of both of these groups of buckets appeared to be solution-treated in the as-aluminized (untested) conditions (figs. 14(b) and (d)). A further indication of the instability of the structure of the air-melted material relative to the vacuum-melted material may be had by comparing the elongation curves in figure 12. The vacuum-melted groups (groups 1 to 4) did not elongate as much as the air-melted groups (groups 5 to 7).

(c) As-cast air-melted group-5 bucket operated 120.8 hours. Note agglomeration of fine precipitates.

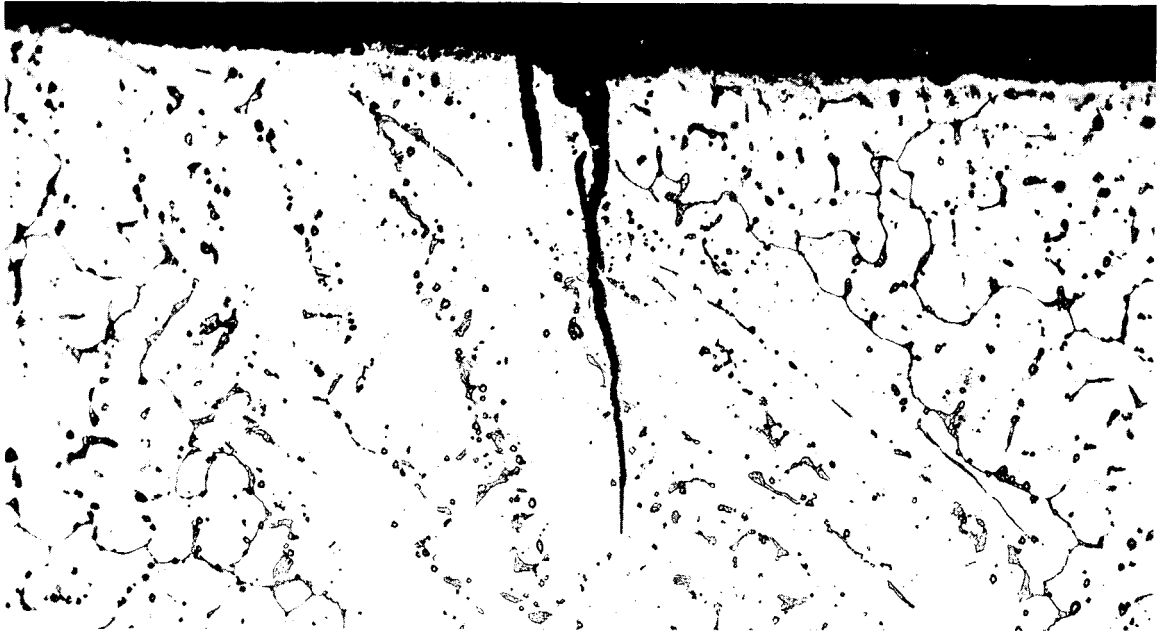
Figure 18 shows photomicrographs of typical leading-edge cracks observed in the GMR 235 buckets. The cracks followed either a transgranular path (fig. 18(a)) or an intergranular path (fig. 18(b)). In some instances, the cracking appeared to originate in the scale that formed on the buckets during operation (fig. 18(c)). Generally, the cracks propagated at a very slow rate; the longest crack detected was of the order of 0.15 inch.

(a) Typical transgranular thermal-fatigue cracks. Etched electrolytically in a 40 percent hydrochloric acid, 10 percent nitric acid, 50 percent distilled water solution; X100.

Figure 18. - Types of thermal-fatigue cracks observed on leading edges of operated GMR 235 buckets.

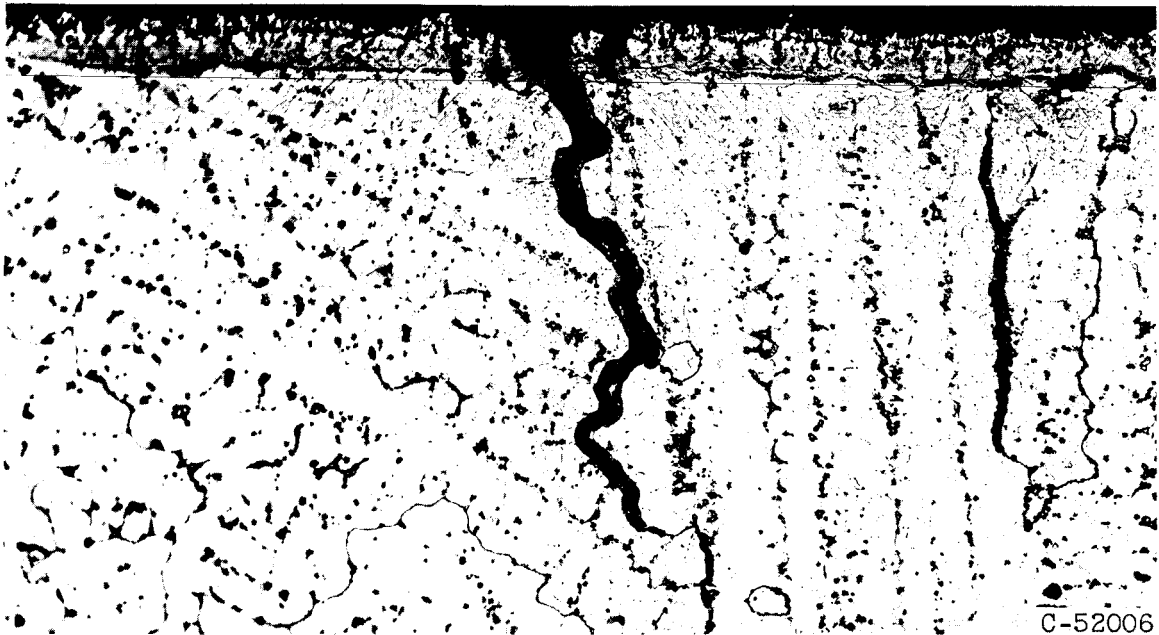
(b) Typical intergranular thermal-fatigue cracks. Etched electrolytically in a 40 percent hydrochloric acid, 10 percent nitric acid, 50 percent distilled water solution; X100.

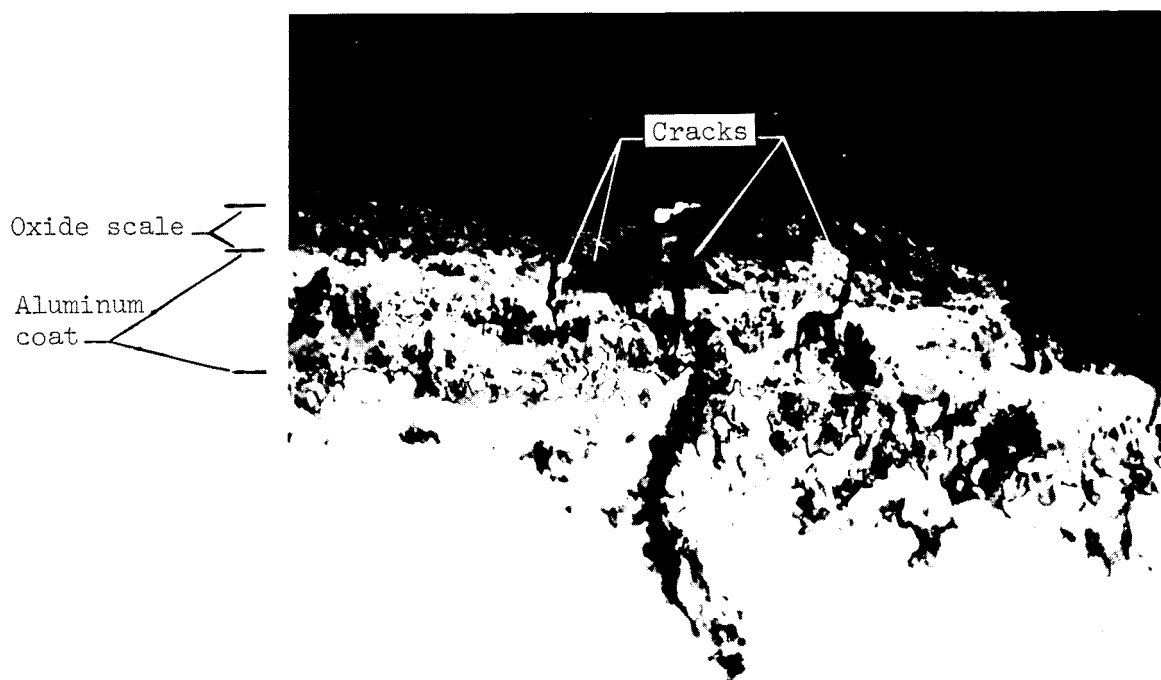
(c) Typical thermal-fatigue crack initiated in oxide scale of operated bucket. Unetched; X750.
